Rijnstroom IV

Rob Lowe tells the story of Rijnstroom IV since he and his wife Elaine purchased her in 2006

Rob Lowe continues the story

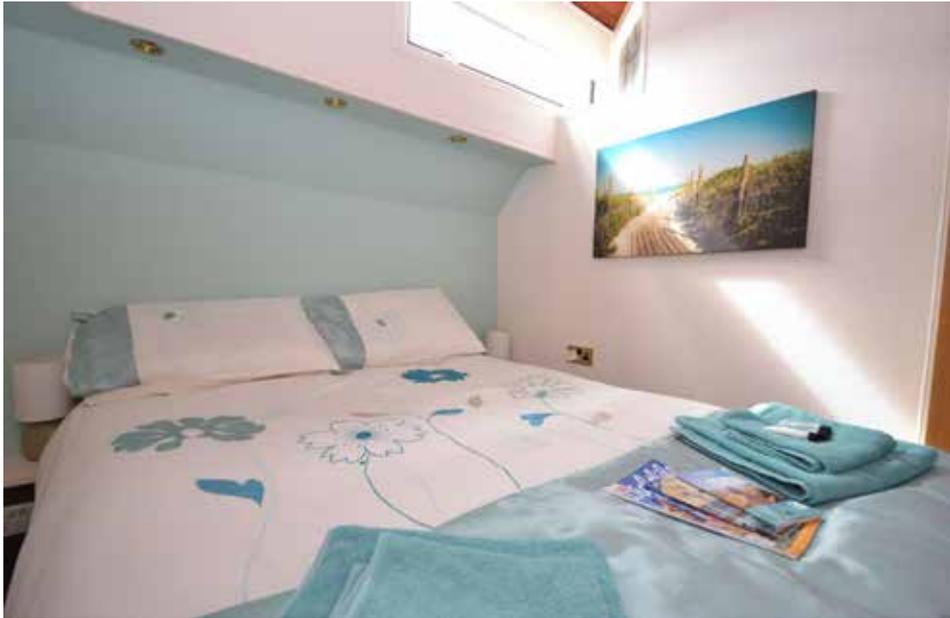
Refurbished cabin and the original style - to the right

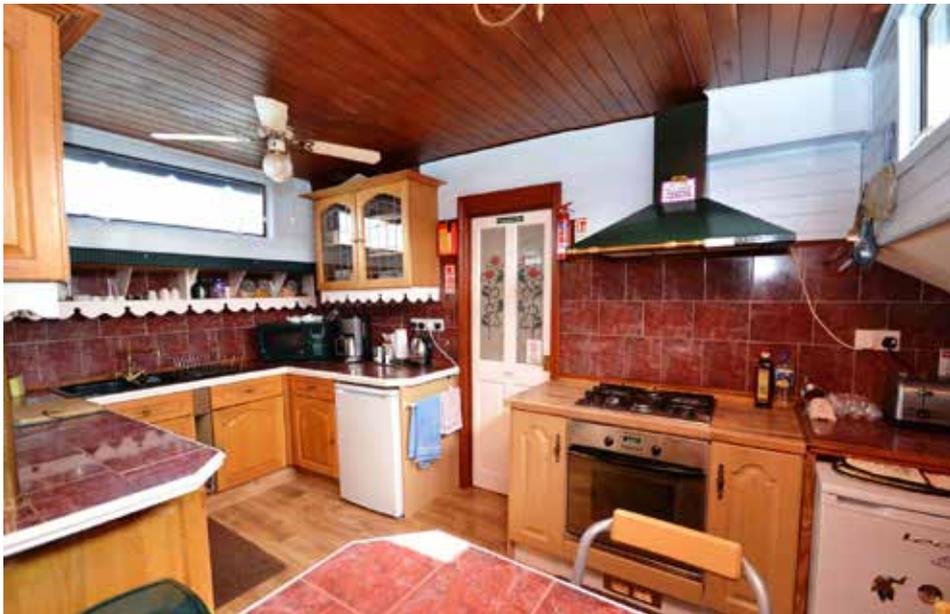
New galley and how it was - to the right

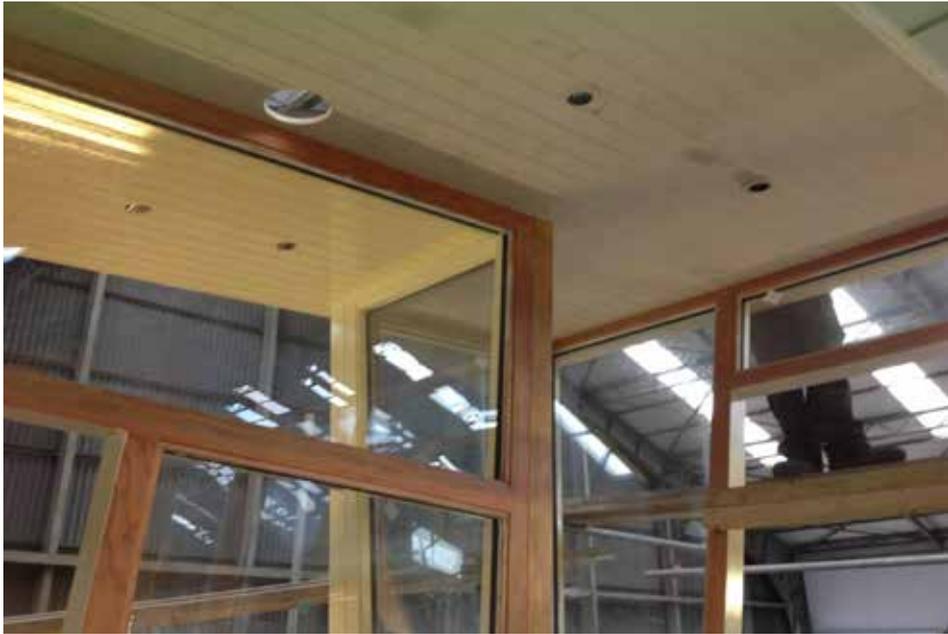
Superb height in the wheelhouse

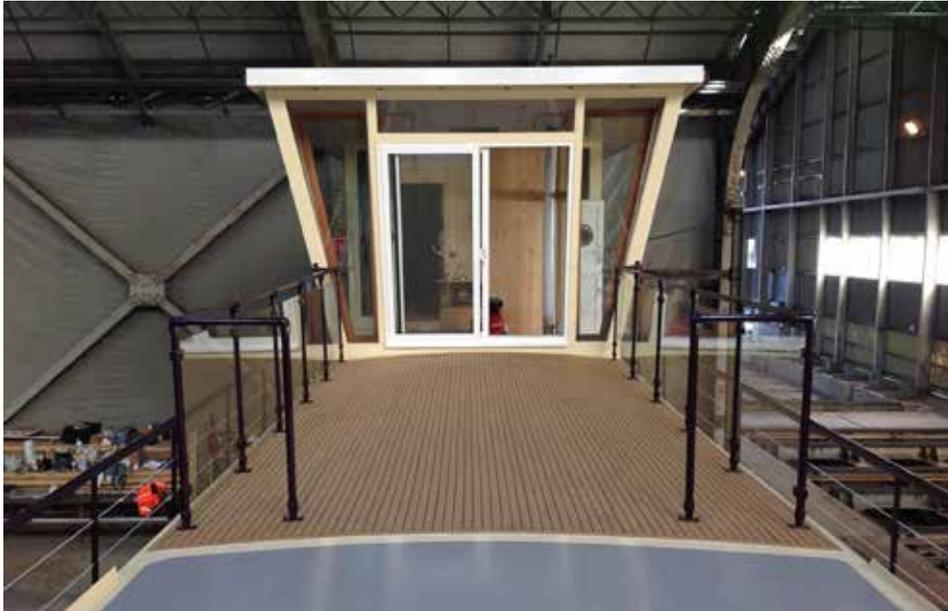
Great outdoor space on the deck with access directly into the wheelhouse

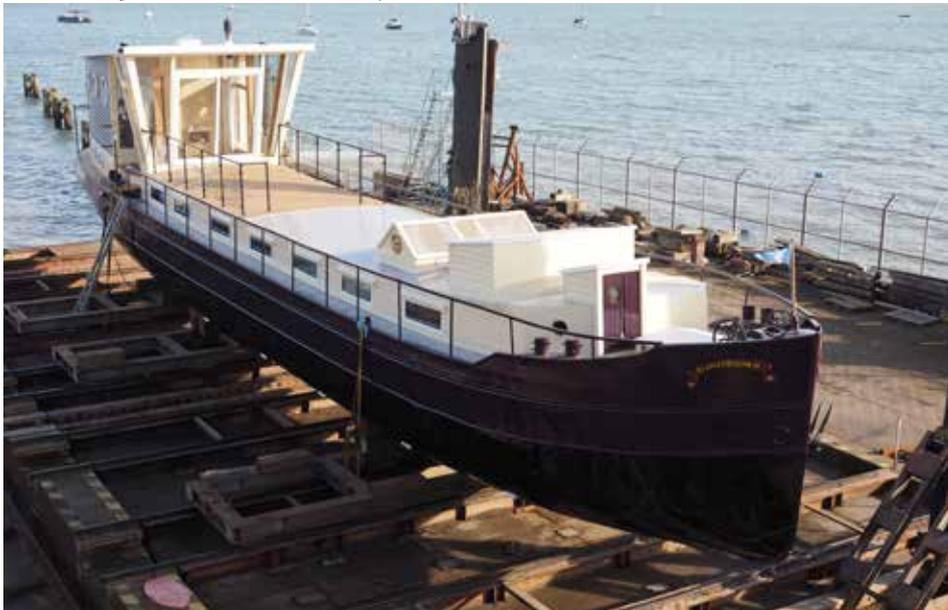
All finished and ready to go back in the water

The entire hull was aqua-blasted to remove all existing paint and hull coatings, right back to bare iron and then painstakingly reapplied using specialist sealers and primers and topped off with polyurethane gloss enamel - 7 coats in all that took me 190 hours to complete. The aqua-blasting also highlighted the degraded hull below the waterline, which despite being completely dry before the fire, was now riddled with small rust holes, missing rivets and previous attempts at minor repairs that had completely rotted away. Structural rot to iron and steel work around the rudder

Once welding was complete, it was down to me to get the new paint finish done. Once again, working in less than a metre of space, climbing over railway sleds, wearing full body and face protection, I was applying highly toxic, skin burning specialist paints, often working with nothing more than an artist's fitch to reach awkward places behind the new keel pipes and an angled head brush and mini roller to apply 5 coats of hull protection, including 2 layers of bitumen.
